# Weekly Construction Report

## Hatchery Creek Design/Build Project

<b>Time Period (two weeks):</b>	September 28- October 10, 2015	<b>Project No:</b>	1305
<b>Rain Days/Weather Conditions:</b>	Rain started on Tuesday, Sept. 29 <sup>th</sup> and rained ~3.2" (Rowena gauge) over the rest of the week. We did not work Tuesday afternoon through the Monday, Oct. 5 <sup>th</sup> . It rained Friday, Oct. 9 in the afternoon and we did not work Saturday.		
<b>Personnel on-site:</b>	<i>EcoGro/Ridgewater:</i> Tom Cutter, Eric Dawalt, Jim Hanssen, Larry Mounce, Brad Redmon, Chad Relinski, Randall "Mokie" Starns, Randall Starns, Jr., Sherri Arthur Trucking-John Arthur.		
<b>Equipment on-site:</b>	Komatsu PC 360 excavator w/ hyd. thumb, Komatsu PC 160 w/ hyd. thumb, Komatsu PC 210 excavator, Komatsu PC 240 excavator, Terex TA27 articulated off-road dump truck, Bobcat T300 skid steer , & Morooka 2200 track dump truck (mobilized Oct. 6th).		
<b>Material deliveries to project site:</b>	<ul style="list-style-type: none"> <li>760 tons of spawning gravel (1,215 tons to date).</li> <li>115 l.f. of 84" equivalent diameter arch corrugated metal pipe with Aluminized Type II protective coating.</li> </ul>

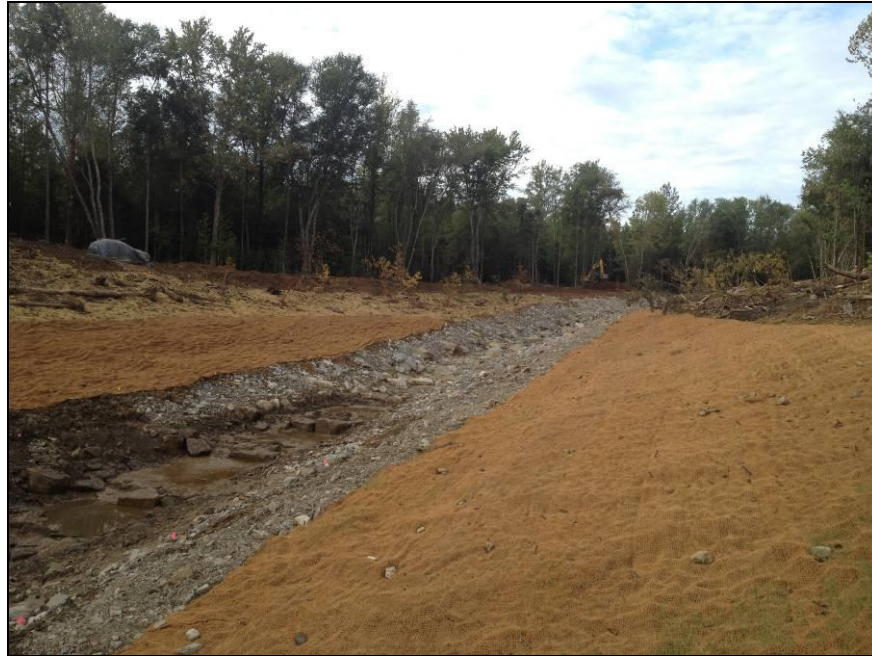
**Site #3: Erosion control blanket installed on lower slopes of step pool reach. (Picture taken on September 28<sup>th</sup> on LDB at ~Sta. 159+00 looking upstream).**

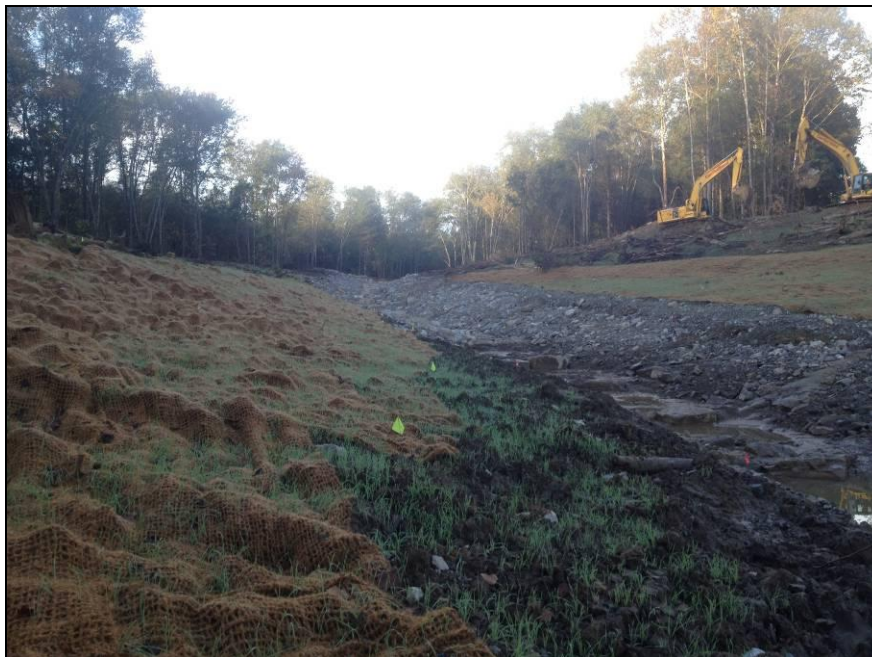
**Site #3: Eight days after above picture was taken, grass is growing up through ECB. (Picture taken on October 6<sup>th</sup> on RDB at ~Sta. 159+00 looking upstream).**

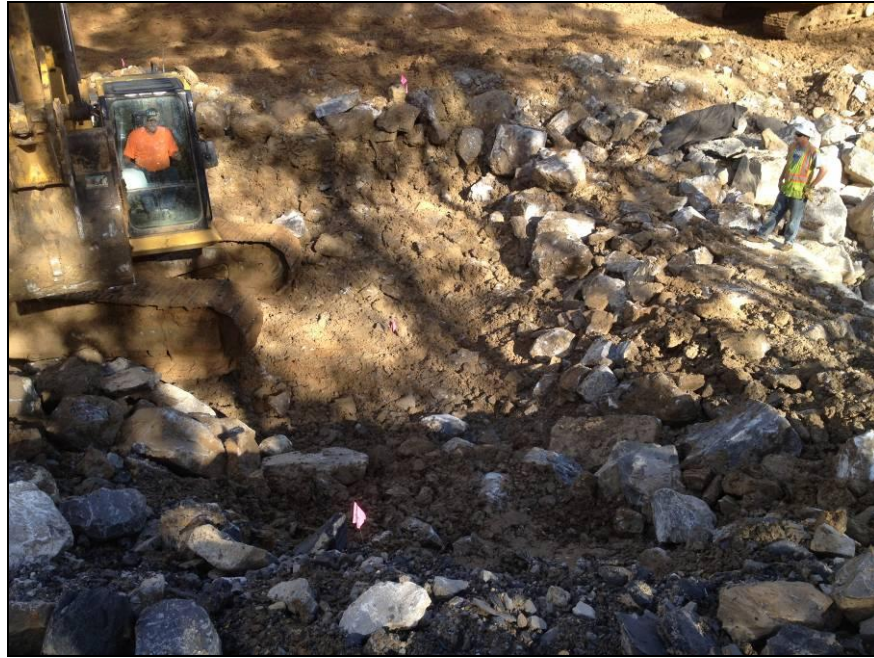
***Site #3: Preparing to install step pool at Sta. 154+00. (Picture taken looking towards Left Descending Bank).***

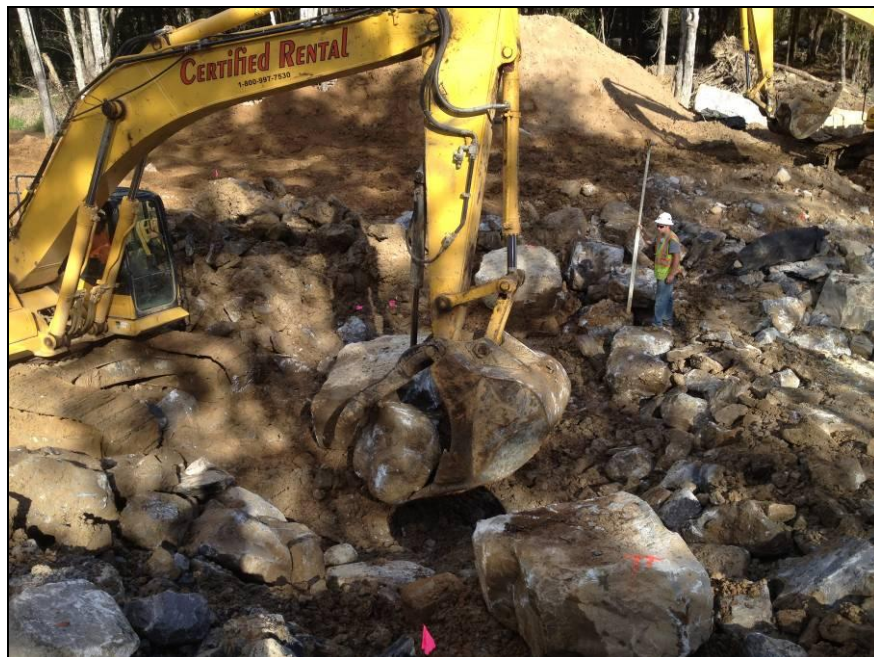
***Site #3: Installing boulders rock steps. (Picture taken from same location as above).***

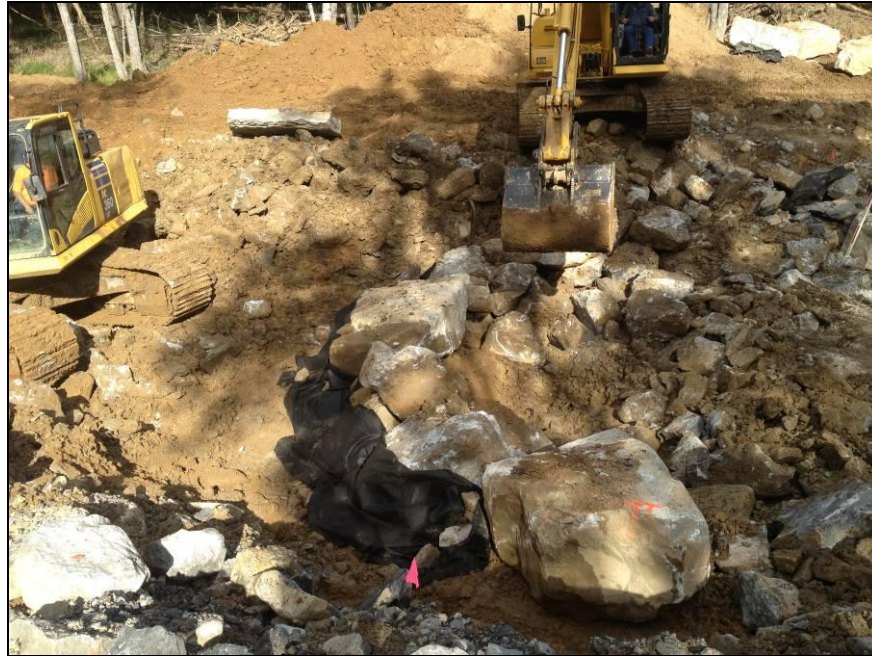
**Site #3: Rock step installed with geotextile fabric upstream to keep gravels from washing through boulders. (Picture taken from same location as above).**

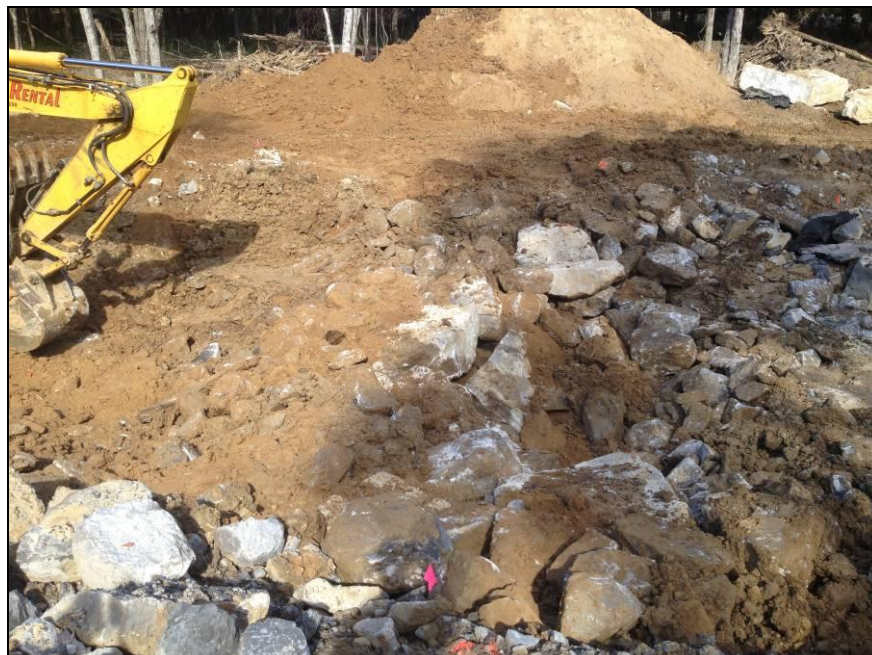
**Site #3: Rock step with smaller rock placed upstream of geotextile and boulders. (Picture taken from same location as above).**

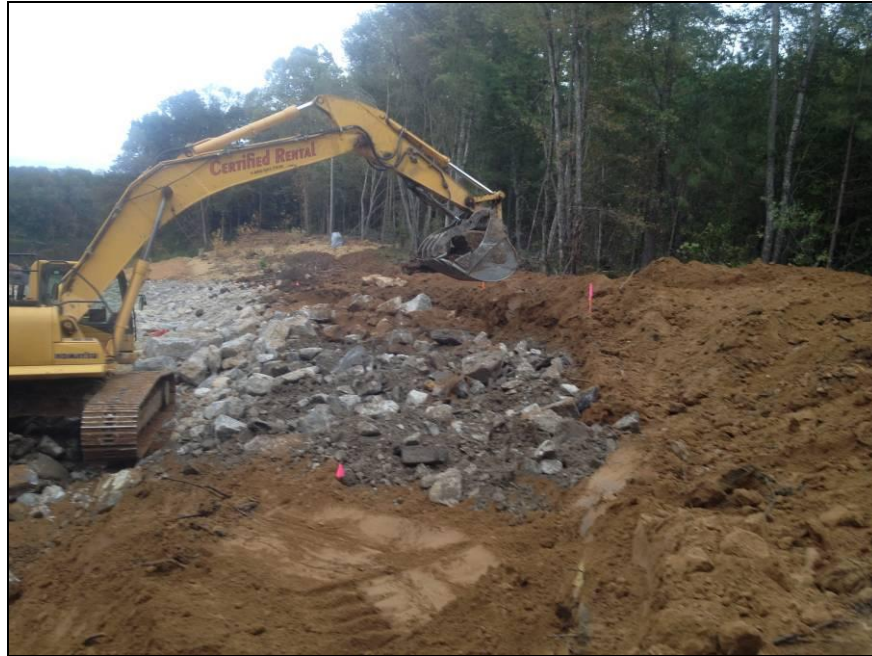
**Site #3: Installing step pool funnel at head of step pool reach. (Picture taken from RDB at ~Sta. 153+50 looking downstream).**

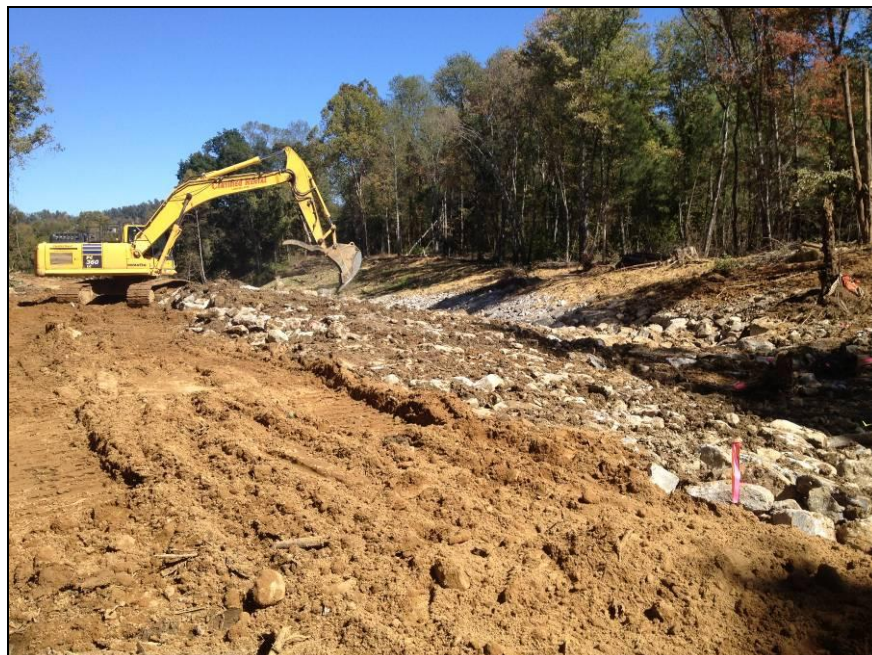
**Site #3: Installing step pool funnel at head of step pool reach. (Picture taken from LDB at ~Sta. 153+50 looking downstream).**

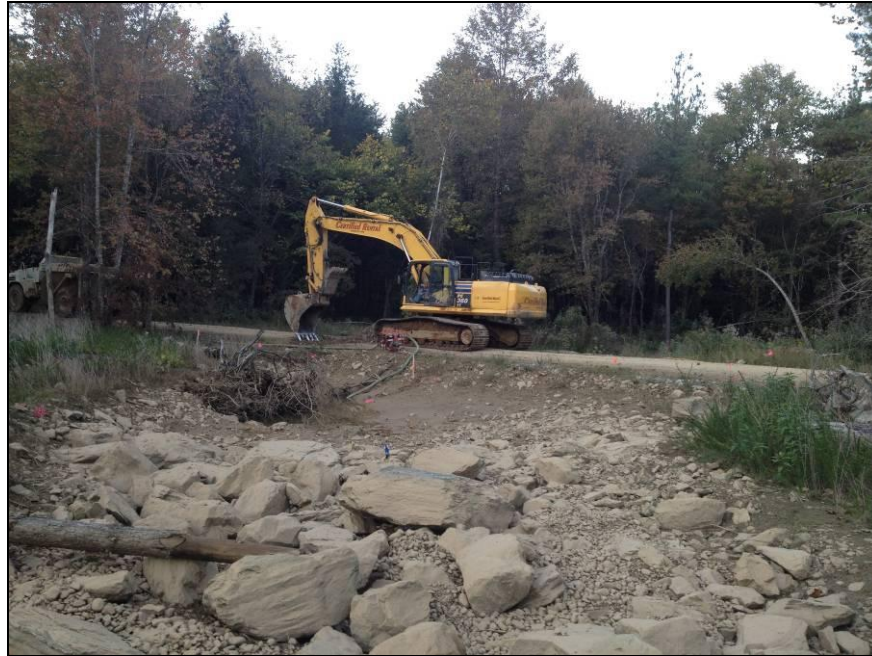
**Site #2: Preparing to install low water road crossing at ~Sta. 149+00. (Picture taken from ~ Sta. 148+40 looking downstream).**

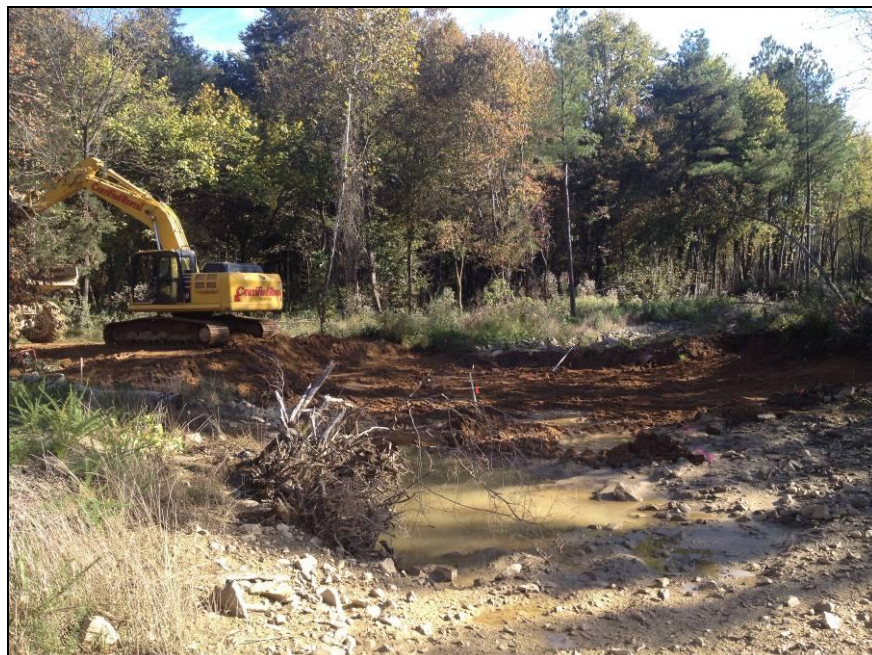
**Site #2: Excavating for low water road crossing at ~Sta. 149+00. (Picture taken from approximate same location as above).**

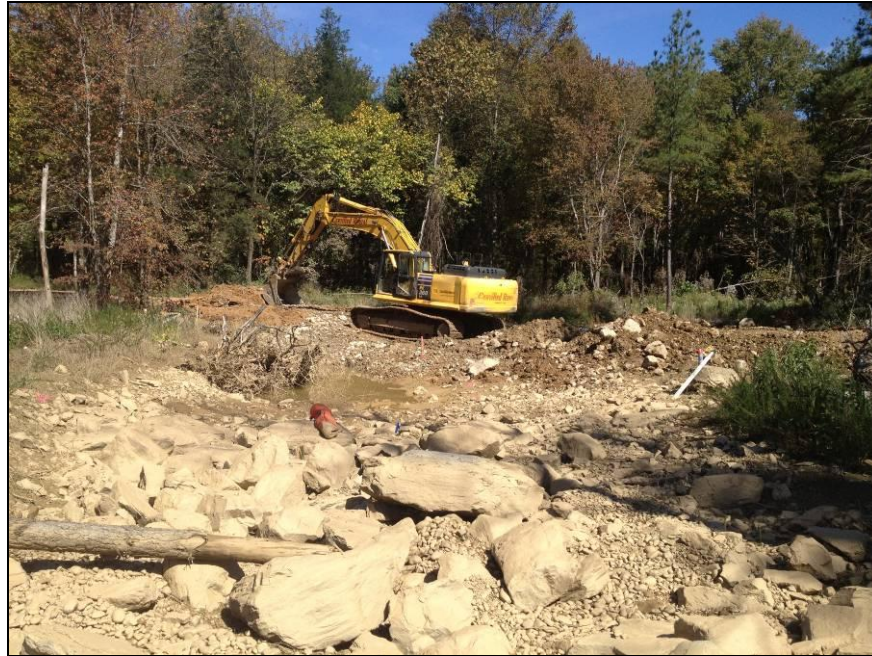
**Site #2: Installing rock in low water road crossing at ~Sta. 149+00. (Picture taken from approximate same location as above).**

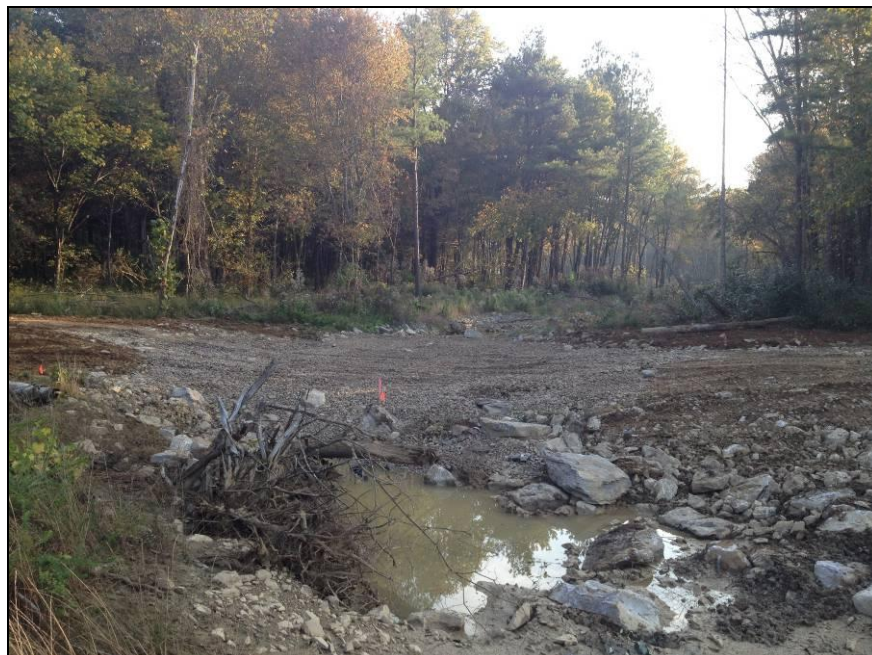
**Site #2: Completed low water road crossing at ~Sta. 149+00. (Picture taken from approximate same location as above).**

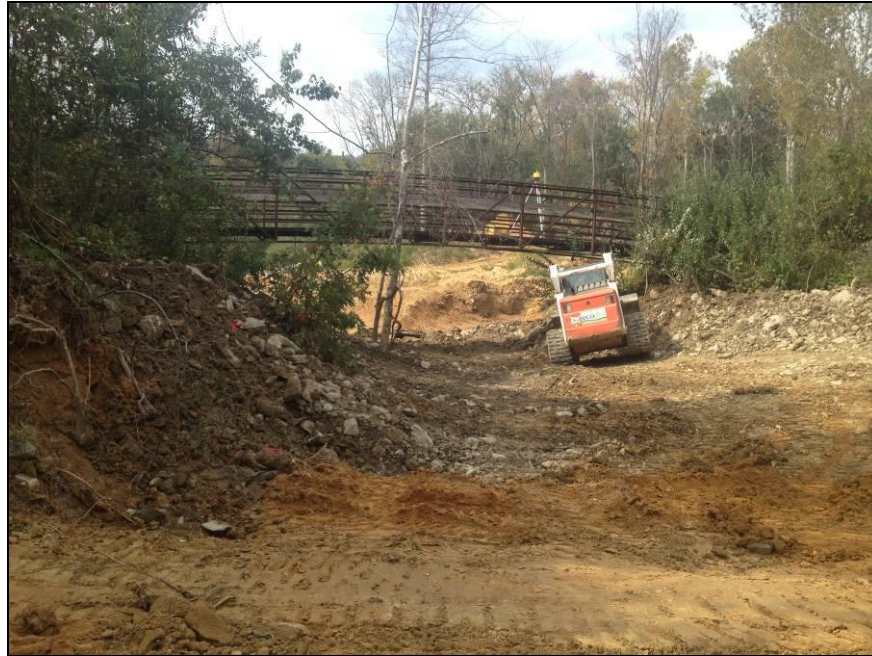
***Ravine upstream of bridge: Lining soil banks and channel bottom with rock to protect them from erosion. (Picture taken in ravine at ~Sta. 3+60 looking downstream).***

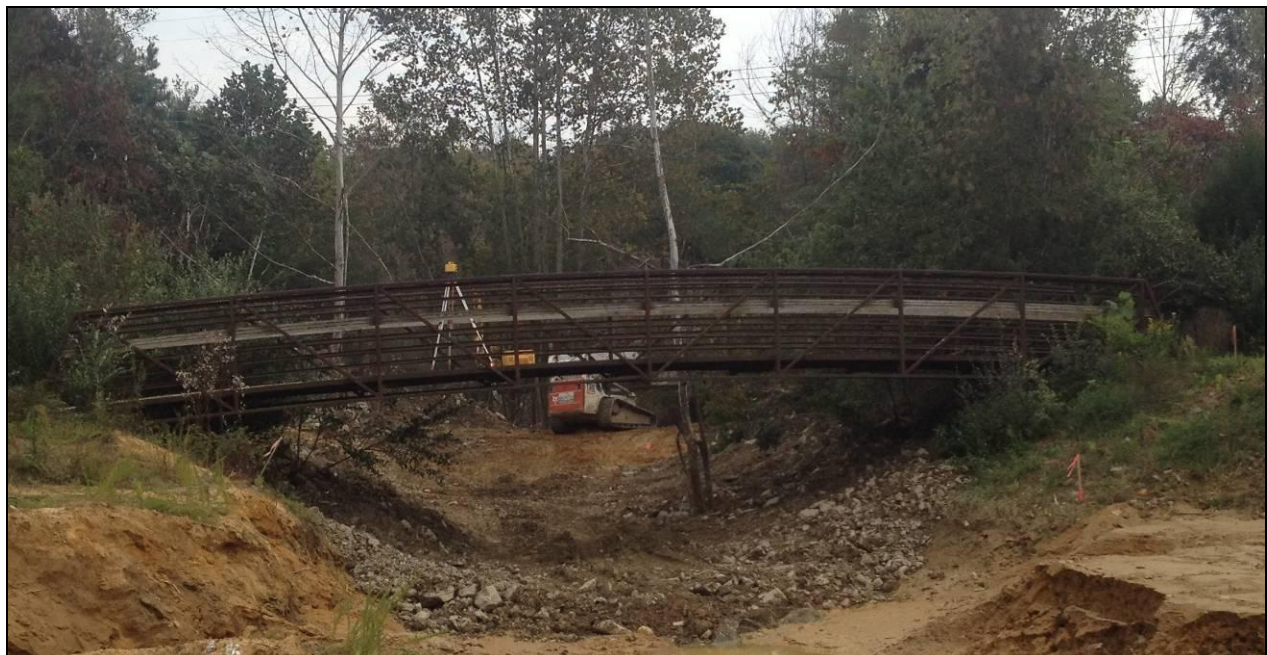
***Soil banks and channel bottom under bridge have been lined with rock to protect them from erosion. (Picture taken in ravine looking upstream).***
